# TROUBLE SHOOTING GUIDE FOR PNEUMATIC C-RING TOOLS

Form No. 10541

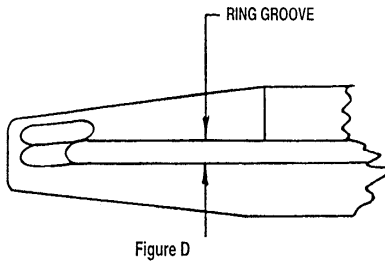
Figure D

- Magazine –
  1. Damaged or bent (changes position of shoe)
  2. Too many shims (Ring passes under shoe without raising shoe; ring out of control)
  3. Too few shims (Ring must be forced under shoe which “bottoms out” and may deflect magazine itself)
  4. Worn shoe
  5. Magazine shoe groove worn
  6. Frequent jamming can cause the shoe groove in the magazine to bend and increase the groove width
  7. Loose or lost rear magazine mounting screw (magazine is not supported properly)
- Pusher spring loose
- Feeder blade –
  1. Worn (holes, length, thickness, leading edge)
  2. Broken
  3. Bent
- Ring groove in jaw worn (see figure “D”)
- Defective rings –
  1. Burrs
  2. Rings skewed on stick
  3. Rings out of line on stick
  4. Rings twisted
  5. Rings not symmetrical
  6. Rings formed to size
  7. Ring strip flare at the ends
- Wrong wire gauge for model of tool

- Magazine –
  1. Replace magazine
  2. Adjust – see Operator Manual
  3. Adjust – see Operator Manual
  4. Replace shoe
  5. Replace magazine
  6. Replace magazine
  7. Tighten or replace mounting screw
- Adjust pusher spring
- Feeder blade
  1. Replace feeder blade
  2. Replace feeder blade
  3. Replace feeder blade
- Replace jaw
- Return sample of rings to your Stanley Fastening representative to be tested
- Verify wire size
  1. 16 ga..06 dia. [1.5mm]
  2. 15 ga..07 dia. [1.8mm]
  3. 11 ga..12 dia. [3.0mm]

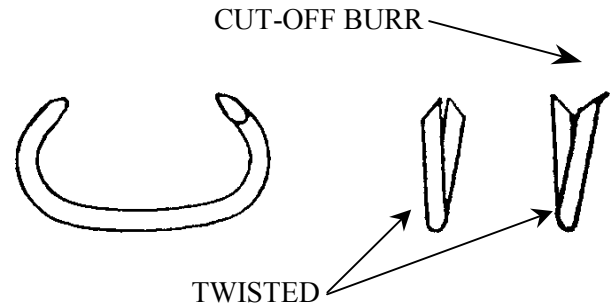
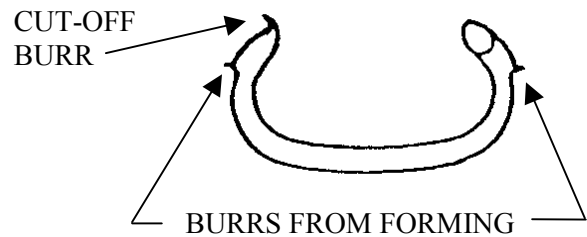
Stanley Fastening System Hogringers are designed to operate with rings manufactured within standard tolerances. As can be seen in the preceding pages, visibly defective rings can be the cause of many ring-forming troubles.

FLARED RINGS IN A STRIP

RINGS SKEWED ON A STRIP

RINGS OUT OF LINE ON A STRIP

LONG  
HANGING  
LEG

SHORT LEG

UNSYMMETRICAL

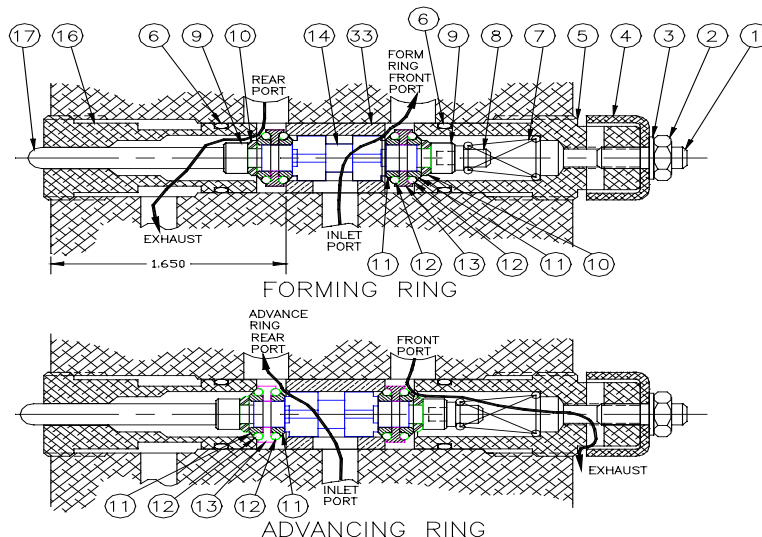
The throttle is basically a pair of two-way valves that divert air in front of, or behind the piston to crimp a ring or load a ring in the jaws respectively. The figures below show the air routings for both positions.

1. Remove front sub-assembly from housing.
2. Do not remove throttle valve bushing (#33), location is preset at Stanley Fastening.
3. Remove air deflector parts (#1, #2, #3, and #4).
4. Loosen set screws (#28) on both ends. Do not loosen center set screw (#28).
5. Remove rear valve seat (#5).
6. Remove throttle spring and locator parts (#7 and #8).
7. Remove front valve seat (#16) and throttle stem (#17) using a 3/16" wrench.
8. Using two 9/64" Allen wrenches, unscrew throttle valve screws (#9) to remove valve units. Hint: Hold housing so that the valve is vertical to help prevent losing parts.
9. One valve screw will remain with other valve parts on spacer (#14), and can be disassembled after removal from housing.

1. Assemble one side of the o-ring support assembly (#9, #10, #11, #12, #13, #12 and #11) on spacer (#14). The chamfer on both washers (#10) should be installed, with chamfer side against cap screw head (#9).
2. Hold housing vertically and install o-ring support assembly with spacer into bushing from the top.

3. Holding cap screw with an Allen wrench, bring second o-ring support assembly (mounted on screw (#9)) in from opposite side and complete valve assembly. The valve should have free motion of travel of about 3/32" [.09" (2.3mm)].
4. Insert valve spring locator and spring (#8 and #7) into the socket head cap screw (#9) in the rear of the valve port.
5. Screw rear valve seat with lubricated o-ring (#5 and #6) into rear of the valve port.
6. Insert throttle stem (#17) into front valve seat (#16) so that the rounded end is out and slowly screw front valve seat with lubricated o-ring (#6) into front of the valve port.
7. Leave trigger guard loose for adjusting the valve. See Throttle Valve Adjustment Procedure for proper valve adjustment instructions.

1. Using the valve stem (#17), slowly screw in the front valve seat (#16) until it bottoms, then back it out 1-1/2 turns.
  2. Do the same with the rear valve seat (#5).

3. Attach an air line and fully depress the trigger. AIR SHOULD LEAK OUT THE REAR VALVE SEAT. While depressing the trigger, slowly turn in the rear valve seat (#5) until the air stops leaking.

4. Release the trigger. AIR SHOULD LEAK OUT OF THE HANDLE. Place a 3/16 wrench on the trigger valve stem (#17) and turn the front valve seat (#16) in slowly until the air stops leaking from the handle.

5. Gently depress the trigger. Air should flow evenly from the rear exhaust to the handle exhaust.
  6. The valve should now be adjusted – test the tool.

7. Tighten the front and rear valve seat locking screws (#28) and re-test the tool.
  8. **Do not loosen or tighten center locking screw (#28), it is preset from Stanley Fastening Systems.**

- Do not screw set screw (#1) in too far or it will result in the tool running sluggish by restricting the air flow.
